Inspection Report
Minerals Regulatory Program
Report Date January 6, 2006

Mine Name: Monoclinic
Operator Name: William Harrison

Permit number: S/037/085
Inspection Date: October 5, 2005
Time: 12:50-1:40 PM

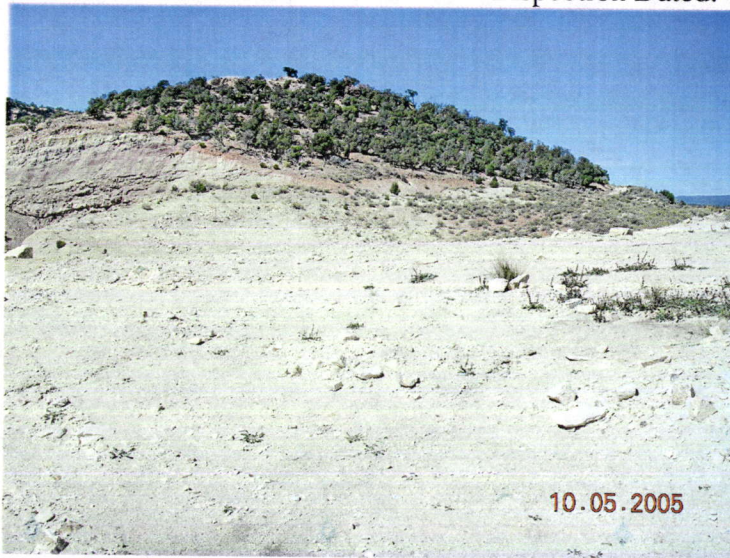
A portion of the disturbed area had been regraded (Photo 1), but there were still piles of material that needed to be smoothed out, such as the area in Photo 2. On October 26, 2005, I received an e mail from Frank Bain with pictures showing this work had been done (Photo 3).

There is a small amount of Indian ricegrass, rabbitbrush, and penstemon in part of the disturbed area (Photo 1).

Photo 1. This is an area the operator previously graded and seeded. There is some sparse vegetation.

The previously reseeded area does not have as much vegetation as surrounding areas, and the operator has requested a variance from revegetation requirements based on previous disturbance and lack of topsoil. The Division needs to evaluate this request. I would like to wait and see whether vegetation becomes established on the newly-seeded areas before granting the variance or releasing the site.

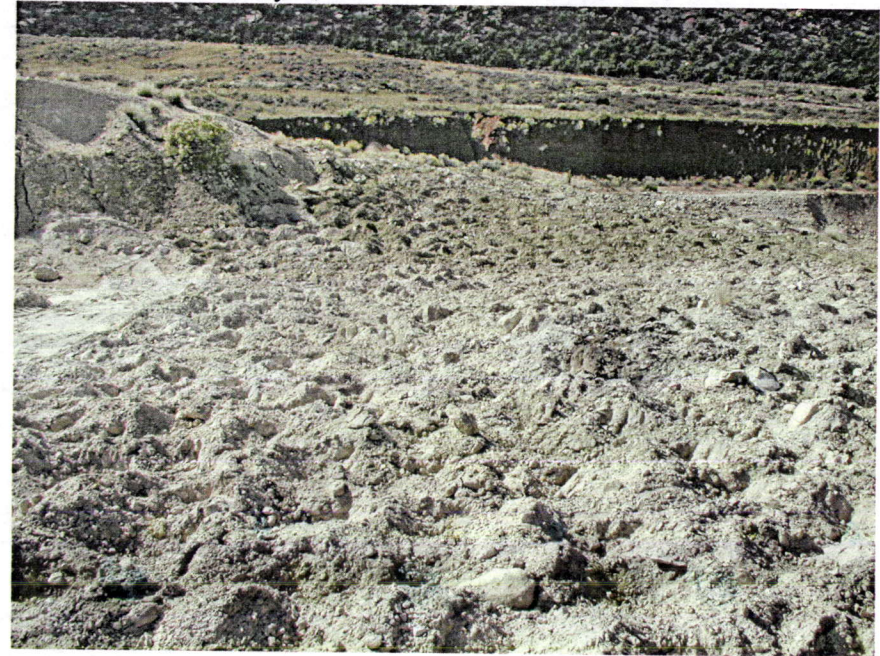
We discussed how to roughen and seed the area, and Photo 3 shows how the site was roughened. Mr. Harrison did an excellent job; this is exactly what I was looking for.

Photo 3. This photo was taken by Frank Bain and received October 26, 2005. This is the surface preparation work the operator did and is a similar view to that shown in Photo 2.

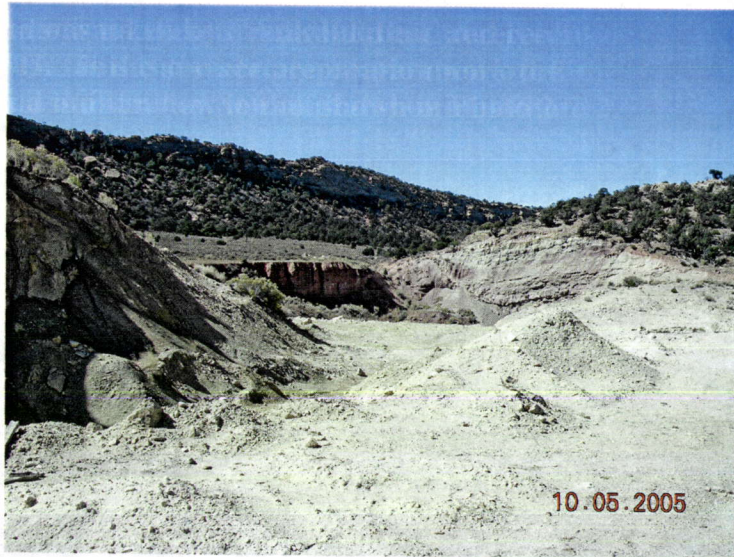
Photo 2. A few places needed additional grading which has now been done.
